WHITMANS POND DAM

MA 00775

PHASE I INSPECTION REPORT
NATIONAL DAM INSPECTION PROGRAM

AUGUST 1980

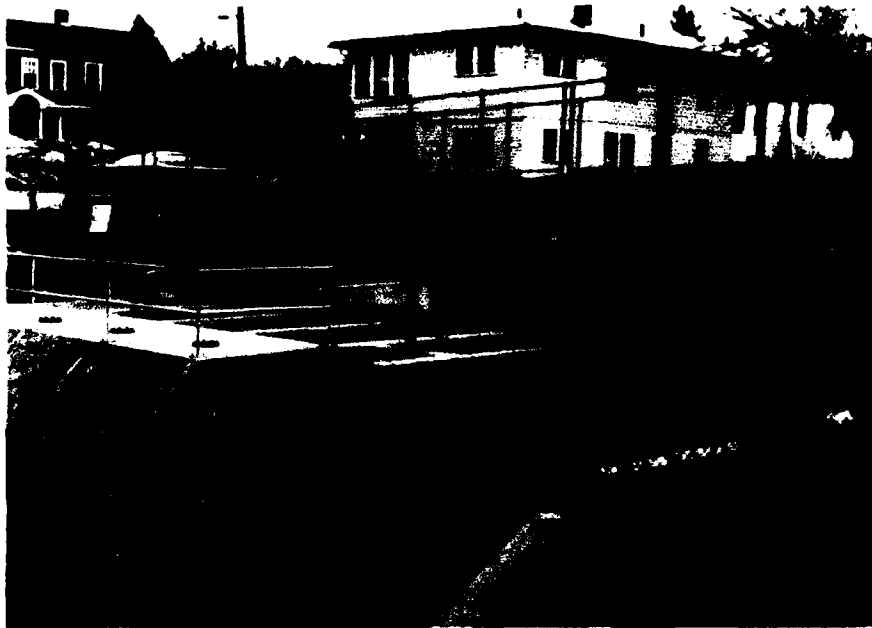
9. Downstream face of dam from left abutment
